# Supplemental Treatments for Timber Bridge Components

H. M. Barnes  
T. L. Amburgey  
M. G. Sanders  
G. B. Lindsey

## Abstract

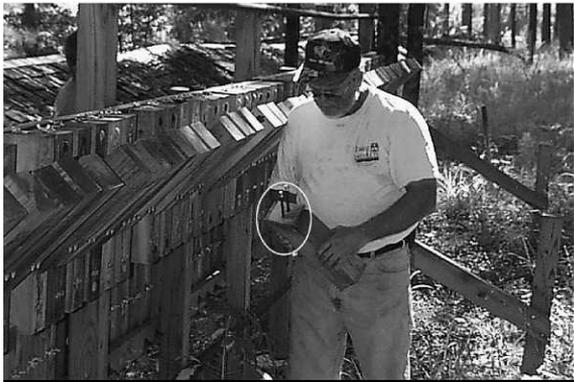
Figure 1.—Application of felt pads between members at joint.

*Supplemental treatments.*—P-R units were constructed (1) with and without porous pads (felt) placed between the joining timbers (Fig. 1; Amburgey et al. 2007, 2009; Amburgey and Sanders 2008; Sanders and Amburgey 2009); (2) with holes bored adjacent to joints to serve as fumigant or preservative reservoirs; or (3) wood-to-wood joints alone. These configurations tested the efficacy of pads or capped holes as reservoirs for supplemental treatment chemicals. Treatments consisted of injecting or applying a fumigant (WoodFume, Osmose Co.), solvent-borne preservative (copper naphthenate), water-repellent preservative (copper naphthenate plus paraffin), diffusible borate rods (Impel rods, Viance Corp.), waterborne borate preservative (BoraCare, Nisus Corp.), and copper-borate paste (CuRap 20, ISK Biocides). The focus was on the use of candidate systems with lower environmental impact. Test units were placed on specially designed test fences at the Dorman Lake test site (Fig. 2).

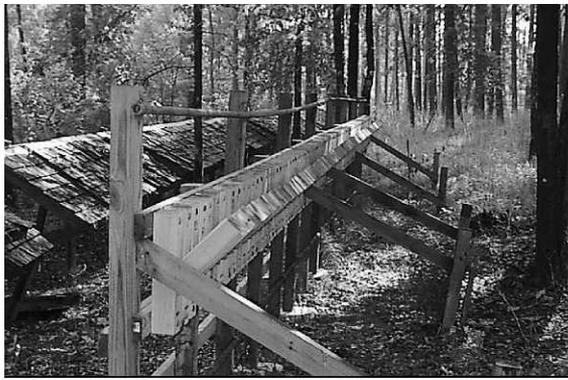
Figure 2.—Post-rail units exposed on vertical test fences at the Dorman Lake test site in American Wood-Preservers' Association Hazard Zone 4 (units on right have preservative paste applied to the joint [circle]).

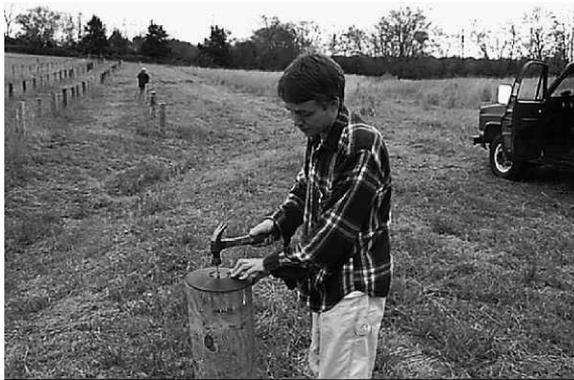
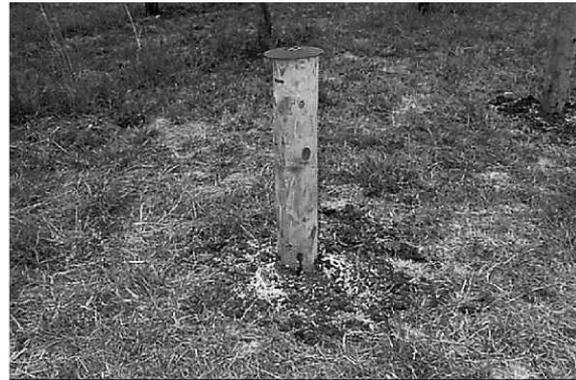
Figure 3.—Installation of caps and pole stubs in the test plot.

plugged with Caplug L-11 plugs. Pole stubs had a ProTop (Bayne Co., Spokane, WA) cap placed on the top to protect the end grain from rain wetting (Fig. 3).

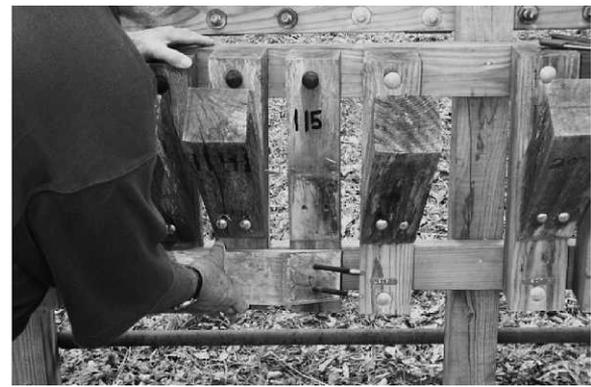
Figure 5.—Post-rail units exhibiting poor (left) and excellent (right) performance after 44 months of exposure.

The group average condition for the P-R units after the 12-, 25-, and 44-month inspections is given in Table 3. Typical performance is shown in Figures 4 and 5. Ratings for treatments applied to holes are compared with untreated P-R units in Figure 6. For yellow-poplar, no treatment applied in holes was considered effective, with an average rating across all treatments of 2.85 after 44 months of exposure. Across all species, the waterborne borate (average = 1.27) and boron rod (1.33) treatments were shown to be most effective. The waterborne borate was the most effective treatment applied to holes for red oak. It was also the most effective treatment for southern pine. Fumigant treatment was not long-lived on any species, as is clear from the 44-month ratings. This likely was due to the short lengths of the P-R members, which permitted loss of fumigant. Work with refractory pole species indicates a longer-lived effectiveness for fumigants (Morrell et al. 2004).

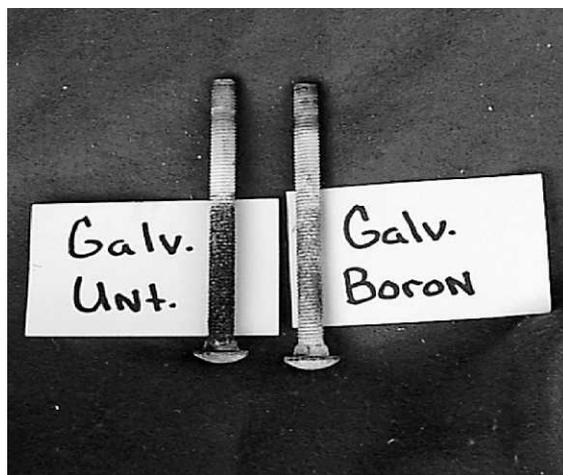
Figure 9.—Corrosion of galvanized bolts was much less in those that had been dipped in BoraCare (1:1) prior to use (left) and a corroded galvanized fastener in an oak test unit (right) after 44 months of exposure.

Iron deterioration at fastener points did not occur in units whose bolt shanks were fitted with heat-shrink tubing, but the unprotected bolt heads and nuts corroded in those exposed in oak test units. The shanks of bolts not protected with heat-shrink tubing had corrosion, especially those in oak test units. Corrosion was significantly less in bolts without heat-shrink tubing that had been dipped in BoraCare prior to use and/or the bolt holes had been treated with BoraCare (Fig. 9). These procedures should be considered when specifying fasteners for bridges and other exposed framing, especially when the structures involved are near salt water.

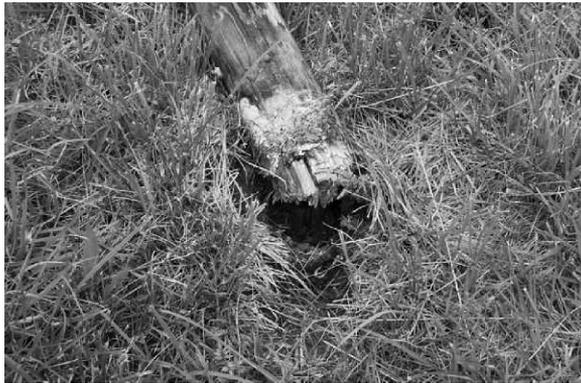
Figure 10.—Typical failed untreated pole stub after 41 months in service in American Wood-Preservers' Association Hazard Zone 4.

specimens. Each pile was rated individually and group averages were calculated for each treatment group for the three exposure periods (Table 4). Figure 10 shows a typical failed pole. Pole stubs treated with in-place treatments containing pastes or grease, alone or in combination with other treatments, remained sound after 41 months of exposure. These results can be seen in Figure 11 and illustrate the effectiveness of pentachlorophenol grease and boron- or fluoride-containing paste systems. Figure 12 shows typical performance of boron and fluoride rods after 22 months in service. Except for the fumigant-boron rod treatment combination, these treatments performed no better than the untreated controls (Table 4). As with the P-R study, the short length of the pole stubs likely was responsible for the loss of fumigant used to treat them.

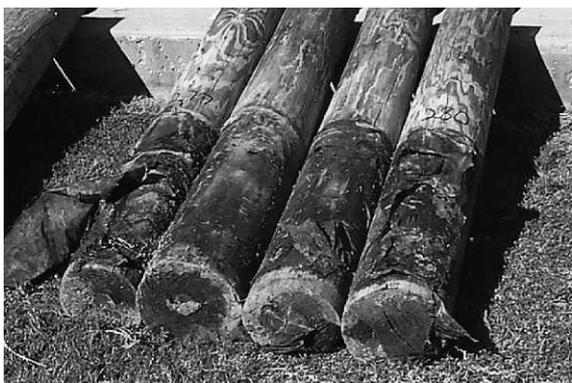
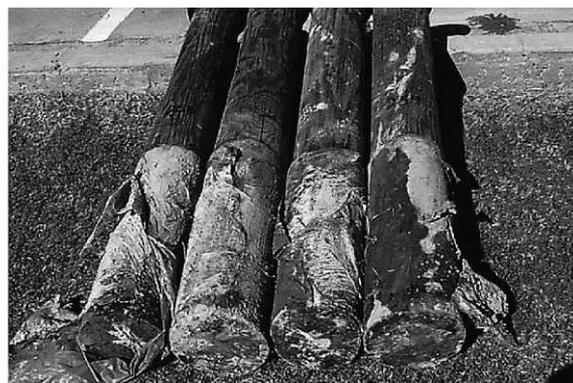
Figure 11.—Typical performance of fluoride paste (left) and copper borate paste (right) treatments with no decay after 41 months of exposure in American Wood-Preservers' Association Hazard Zone 4.

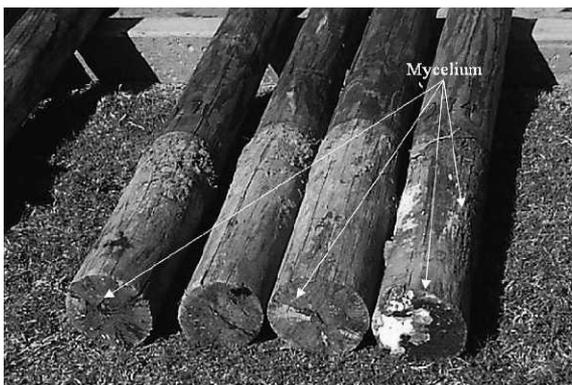
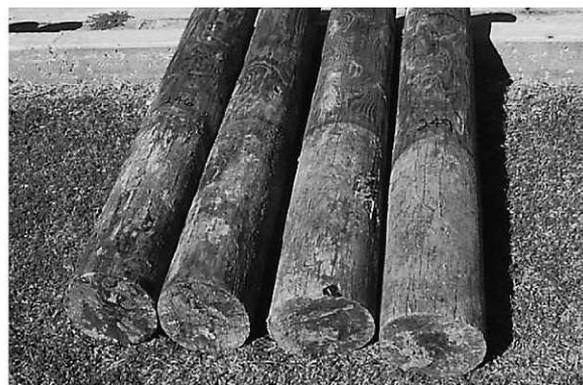
Figure 12.—Performance of fluoride (left) and boron (right) rod treatments after 41 months of exposure in American Wood-Preservers' Association Hazard Zone 4.
